Infrared Survey Of TERWANDARY PTY LTD For BRYCE WOLFF

CUSTOMER / SITE: Terwandary PTY LTD

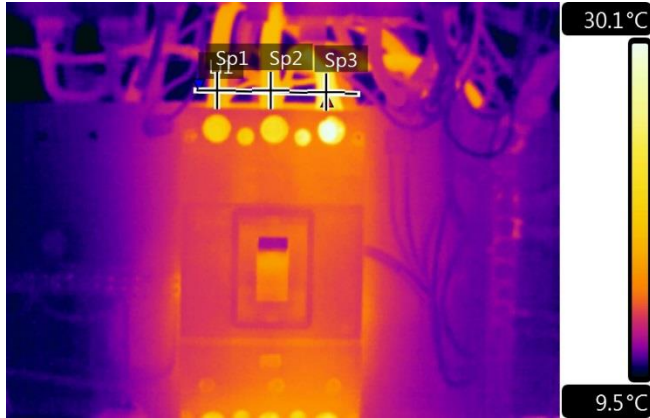
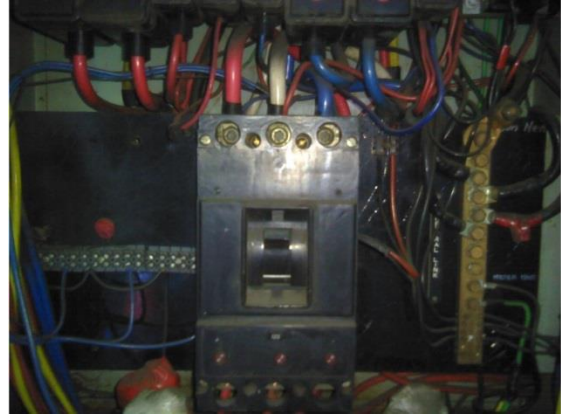
IR_6931.jpg | 13/08/2018 | 8:48 AM

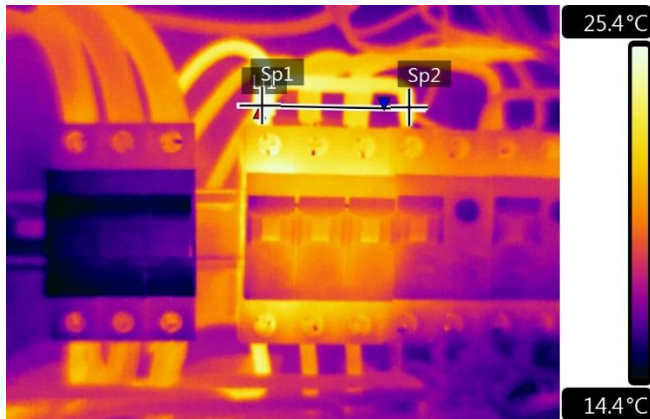
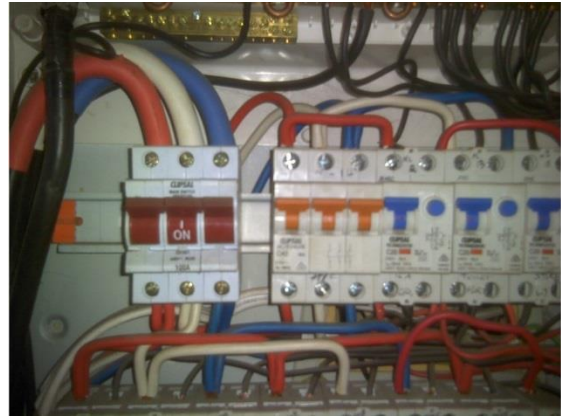
IR_6933.jpg | 13/08/2018 | 9:00 AM

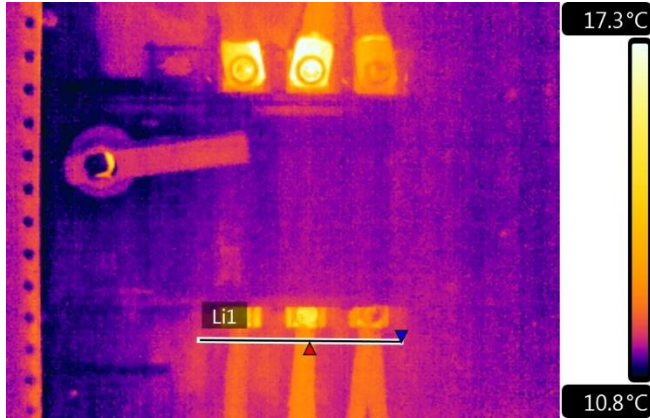
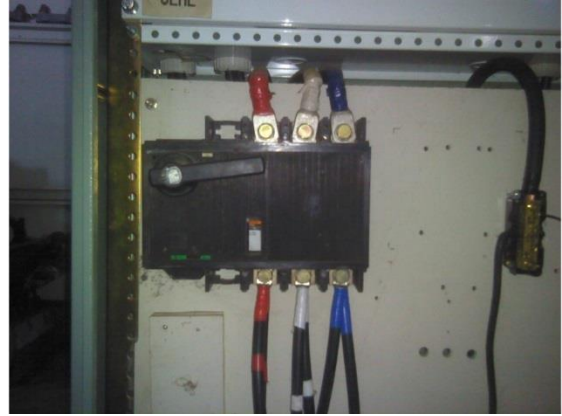
IR_6935.jpg | 16/08/2018 | 7:38 AM

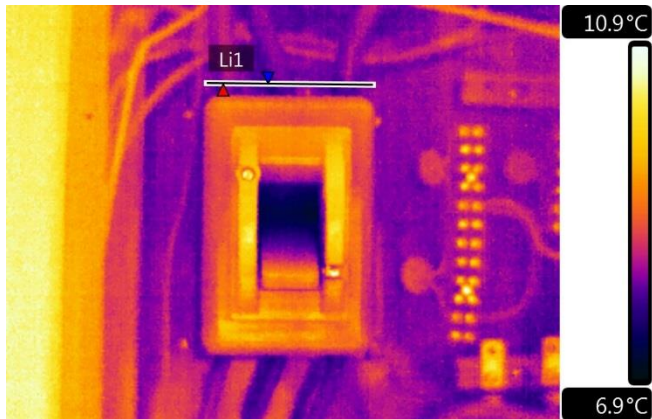
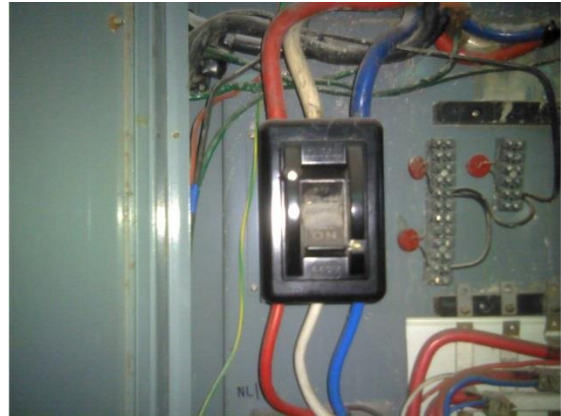
IR_6937.jpg | 13/08/2018 | 9:31 AM

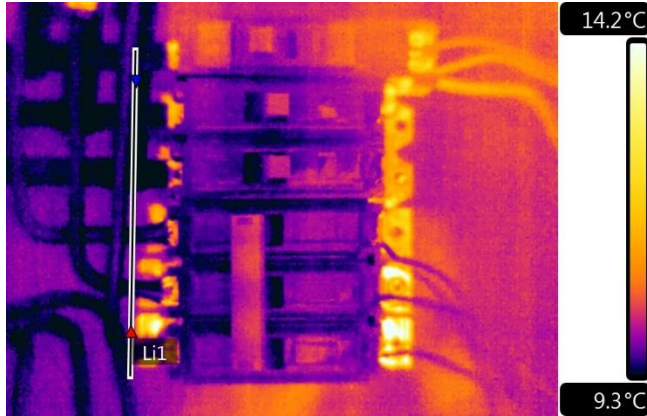
IR_6939.jpg | 16/08/2018 | 7:38 AM

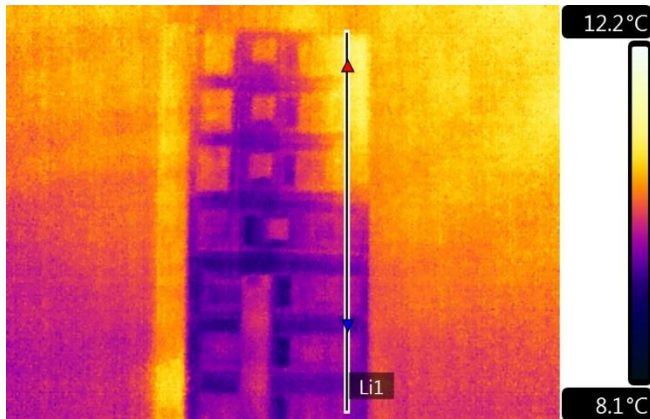
IR_6941.jpg | 16/08/2018 | 7:38 AM

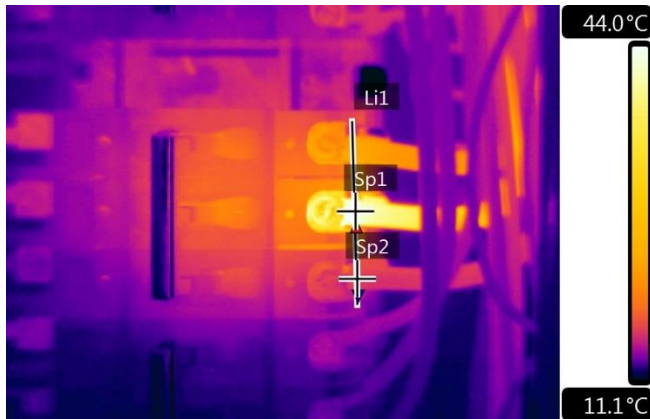
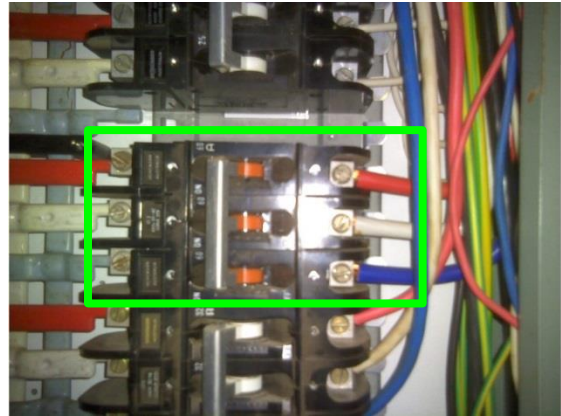
IR_6943.jpg | 16/08/2018 | 7:38 AM

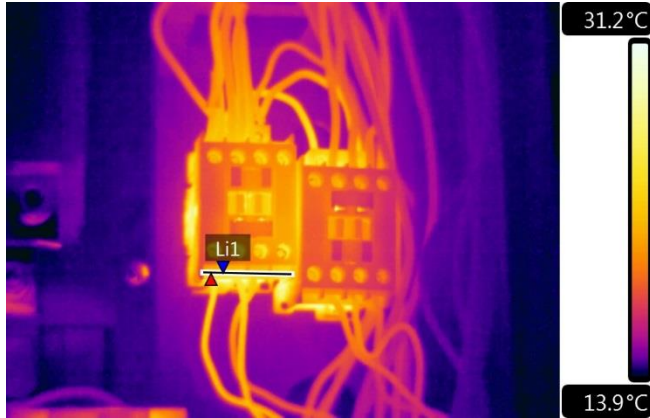
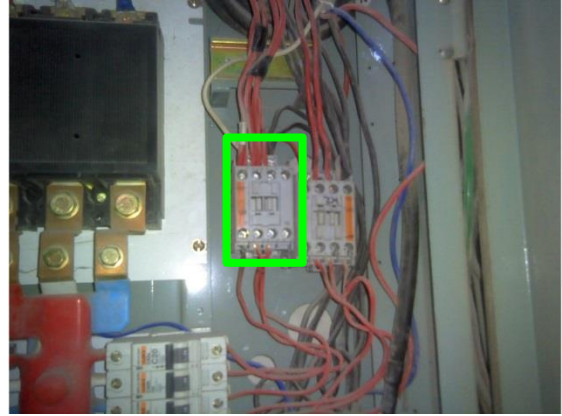
IR_6949.jpg | 13/08/2018 | 10:58 AM

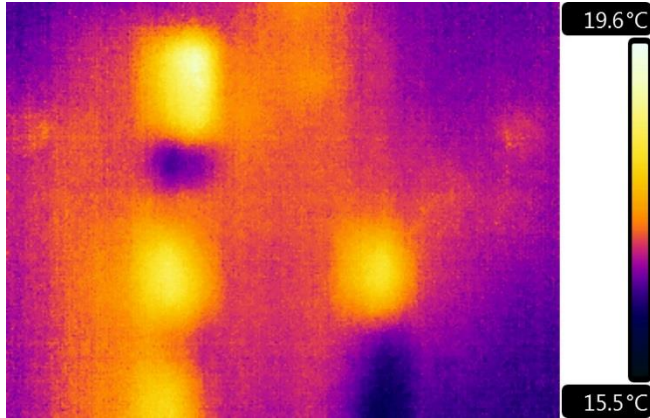
IR_6951.jpg | 13/08/2018 | 11:06 AM

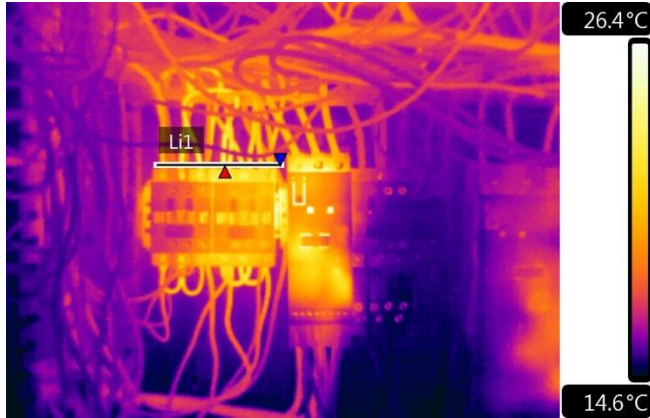
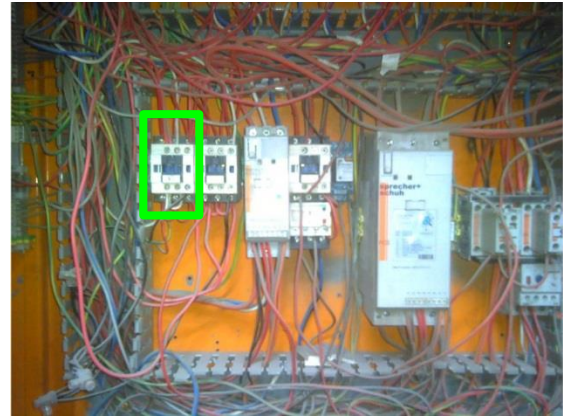
IR_6953.jpg | 16/08/2018 | 7:38 AM

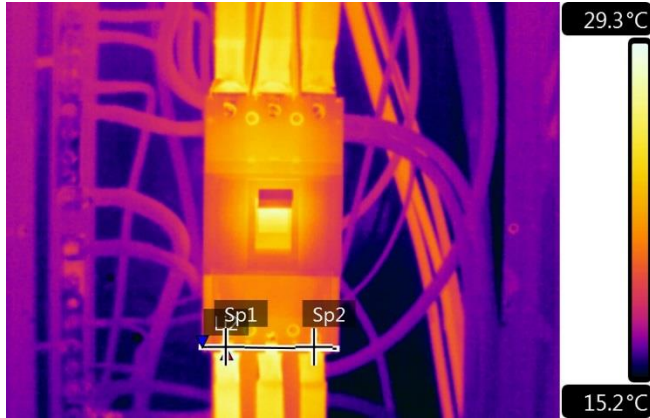
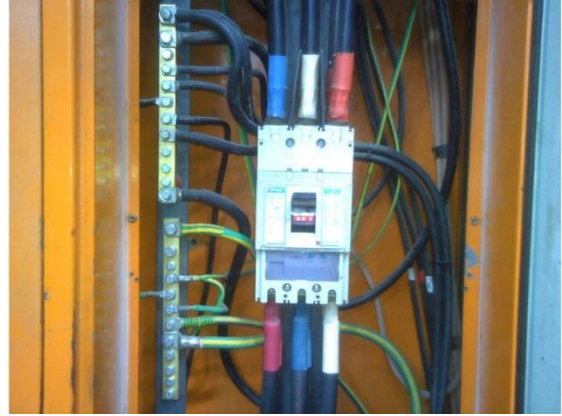
IR_6955.jpg | 13/08/2018 | 11:16 AM
