Thermography Report

Customer / Site

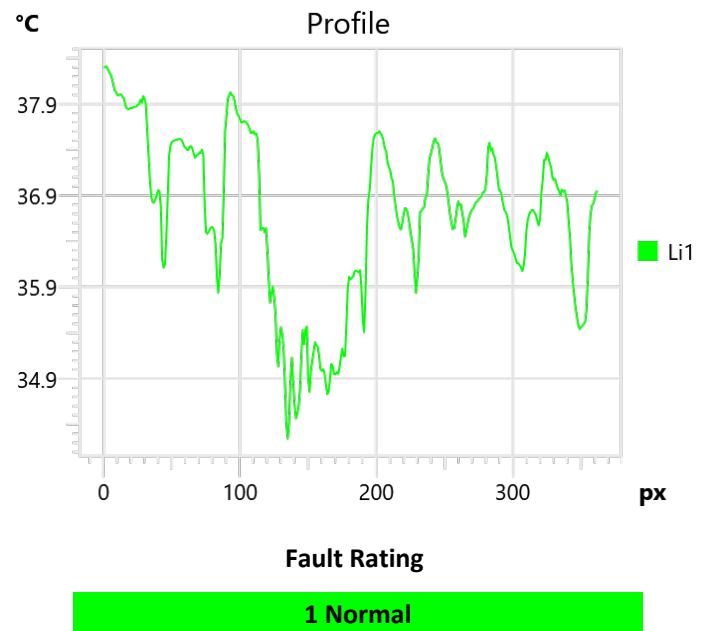
Sp1	37.4 °C
Li1	
Max	38.3 °C
Avg	36.6 °C
Min	34.2 °C

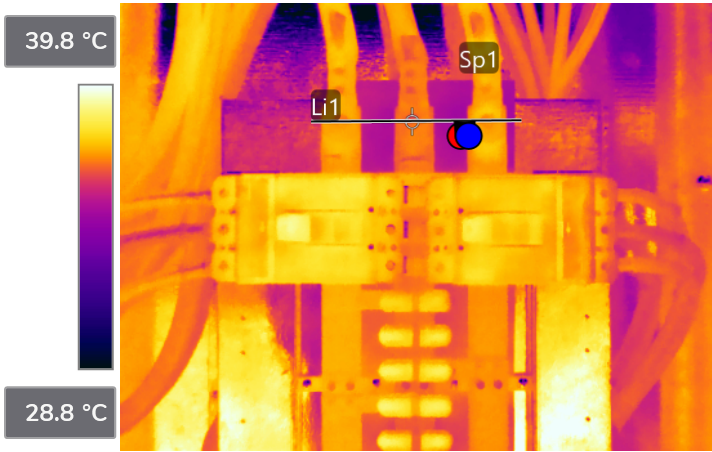
Work Performed	Repaired By:
	Date:

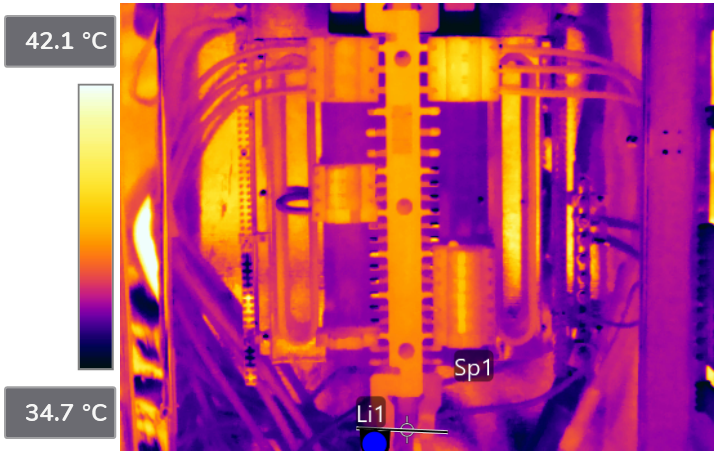
Work Performed	Repaired By:
	Date:

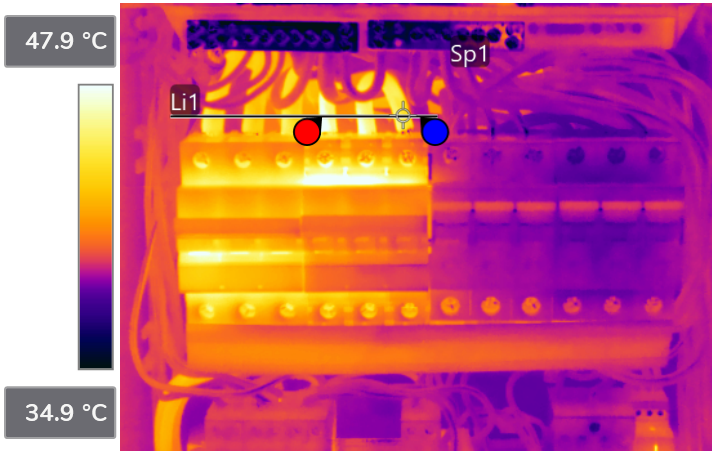
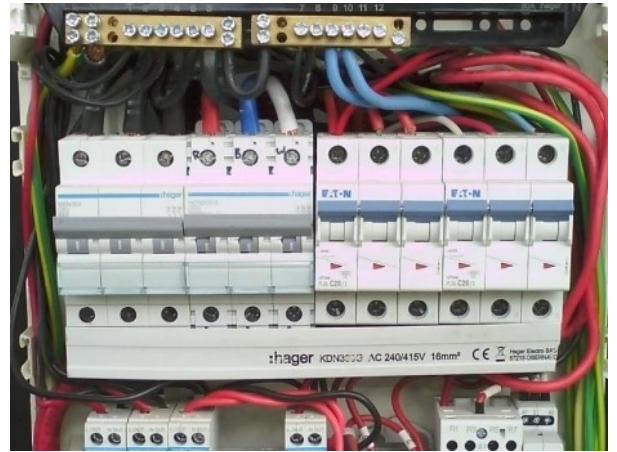
Work Performed	Repaired By:
	Date:

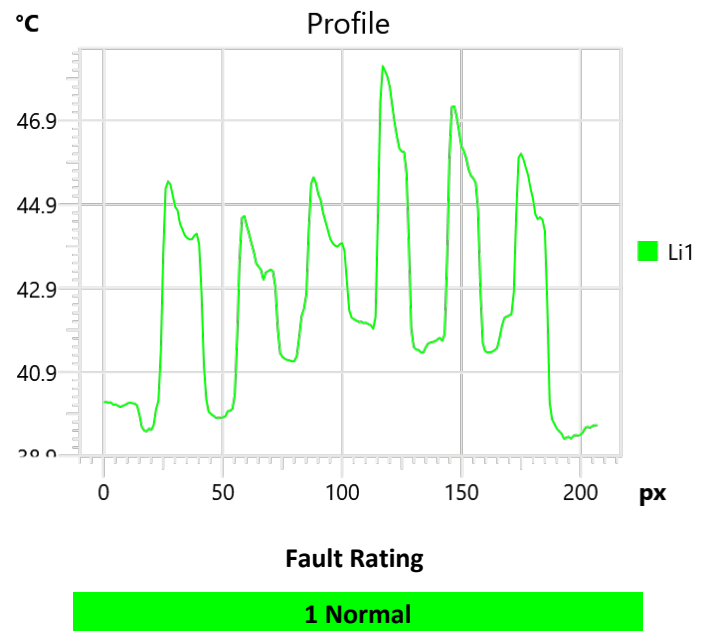
Sp1	44.8 °C
Li1	
Max	48.1 °C
Avg	42.6 °C
Min	39.3 °C
